# Corrective Action Plan Pigeon Property 1705 Route 128 Westford, Vermont 05494

SMS # 2019-4863

July 9, 2021

LEE # 19-138

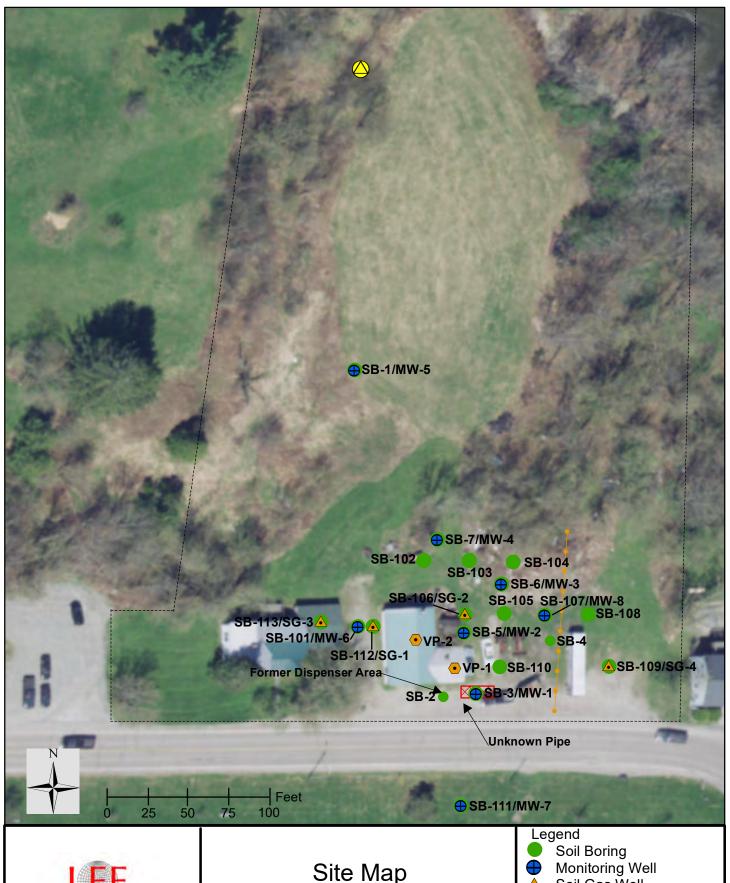
21 North Main Street Unit #1 Waterbury, Vermont Phone: 802-917-2001 www.leenv.net Site Map
Pigeon Property
1705 Route 128
Westford, Vermont

Supply Well
Drain Line

Former Gas UST Drawing Date: 2/1/21 LEE Project #: 19-138
